**DELAWARE RIVER BASIN  
KEEN LAKE DAM**

NDI NO. PA-00092  
DER NO. 64-13

**PHASE I INSPECTION REPORT  
NATIONAL DAM INSPECTION PROGRAM**

Berger Associates, Inc.  
Harrisburg, Pennsylvania

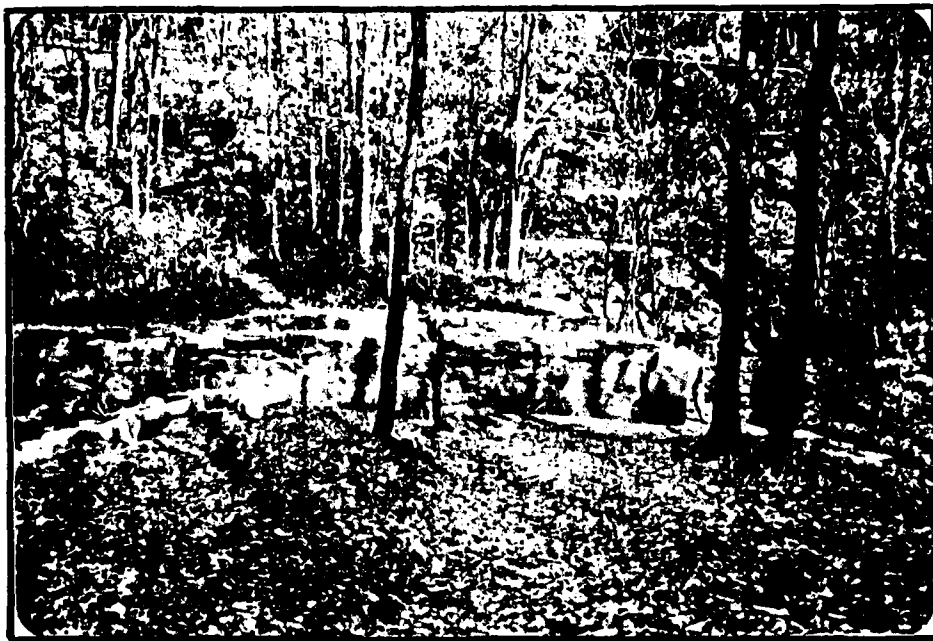
The general appearance of Keen Lake Dam is fair. This relatively old structure consists of an earthfill embankment and a downstream handlaid masonry stone wall. A number of trees are on top of the embankment. Seepage is occurring at the downstream side of the stone wall and the spillway is in need of some repair.

TOP OF EMBANKMENT LOOKING TO THE LEFT END - NO. 2

The operational procedures should be expanded and should include the removal of trees on the embankment. The area should then be seeded to provide a dense protective grass mat. The spillway should be inspected annually and necessary repair work should be performed.

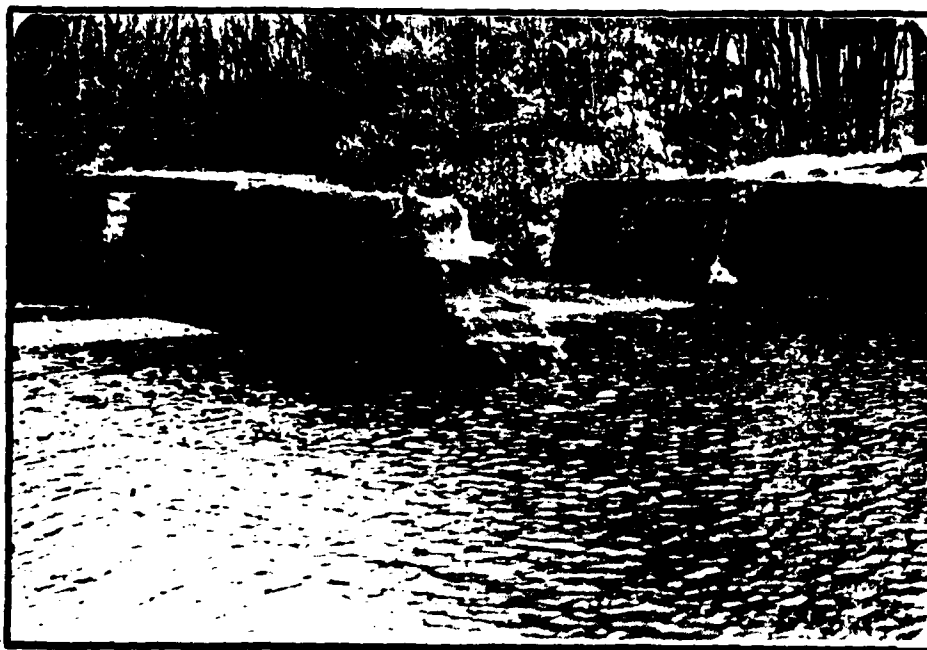
The spillway is formed from stone with a gunited surface. The gunite has cracked severely and the concrete cap of the walls is badly deteriorated. It appears that some stones could be dislodged with high discharges which could endanger the safety of the structure.

UPSTREAM SLUICEWAY AND SPILLWAY - NO. 4

3. That the walls of the spillway and sluiceway be pointed and capped to insure its structural integrity.
4. That the leakage at the downstream wall be monitored on a regular basis noting and recording approximate volume and clarity. If increase in volume or any turbidity is observed, immediate steps shall be taken to identify and correct the condition.

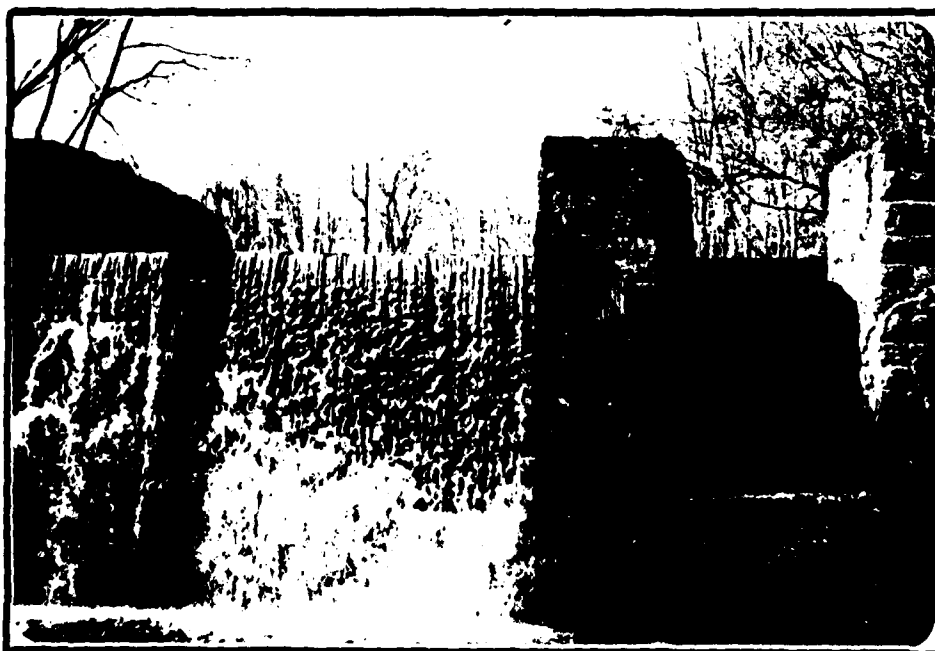
The appurtenant structures are an integral part of the dam and consist of a stone spillway and adjacent sluiceway. The sluiceway is closed off with stoplogs from about 11 feet below spillway crest to slightly above the spillway crest. The stoplogs were replaced in 1978 and are in good condition. The walls of the spillway and sluiceway are in fair condition. The top and sides of the center wall are in need of repair to ensure structural integrity during large discharges.

DOWNSTREAM ELEVATION OF SPILLWAY AND SLUICEWAY - NO. 5

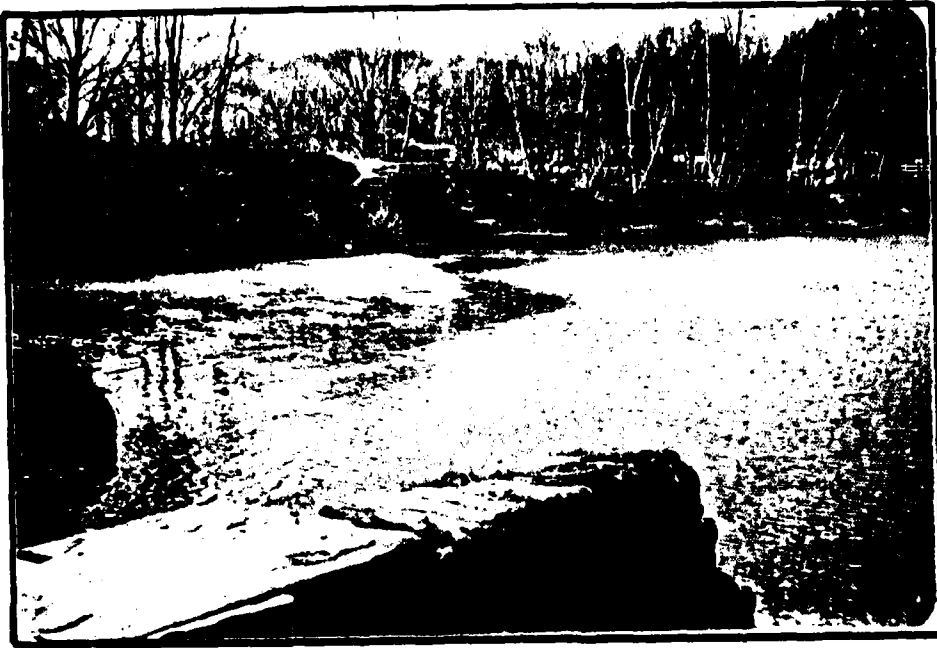
A railroad embankment was constructed across the reservoir about 400 feet upstream of the dam. A 16 foot wide stone arch allows the water to flow from the main reservoir to the small pond between Keen Lake Dam and the railroad embankment. The arch is in excellent condition and the normal water depth at this location is about 7.3 feet (See Plate A-IV, Appendix A). A 160 foot long section of the railroad embankment is lower in elevation than the breast elevation of the Keen Lake Dam. The embankment has many trees growing on it. Several campsites are located on the embankment.

THE UPSTREAM EMBANKMENT WITH ARCH - NO. 6

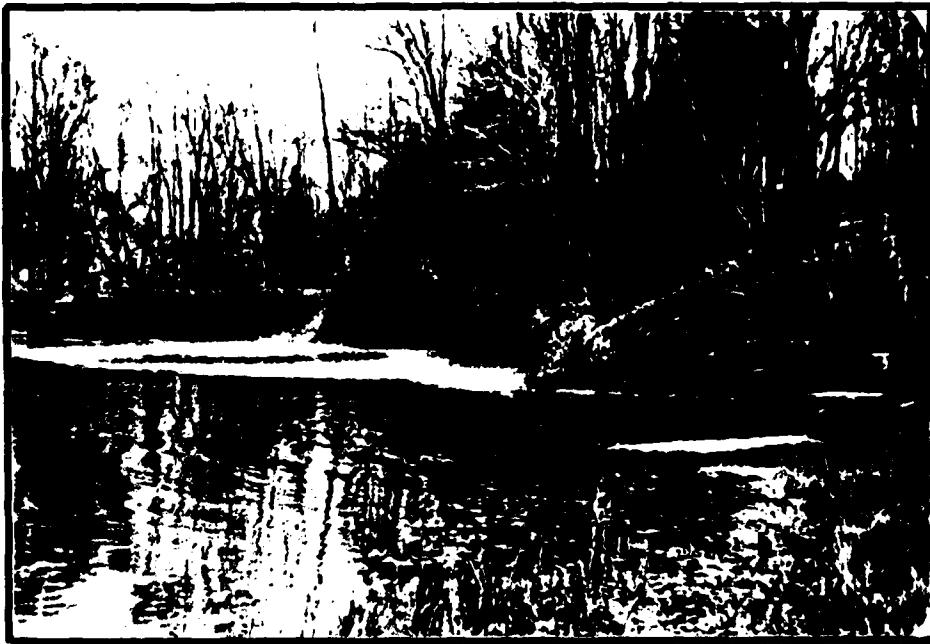
The visual inspection of Keen Lake Dam did not find any major signs of distress which would signify an unstable structural condition. The upstream slope was flat. Although there is very little protective cover on the slope, the protection of the old upstream railroad embankment prevent serious wave damage. The upstream slope and the top of the embankment are covered with a considerable growth of trees, which could cause serious problems when the embankment is saturated.

LOOKING TO UPSTREAM SLOPE - NO. 7
